Maximizing High-Volume Evacuation (HVE) Performance Through Targeted Maintenance

This case study evaluates how a four-operator dental practice struggling with poor chairside suction performance successfully increased airflow velocity by 19.7% without replacing their central vacuum hardware. By transitioning from traditional cleaning with a bucket to advanced line cleaning with an atomizer and structured maintenance protocols, the practice moved from marginal clinical efficacy to robust aerosol control.

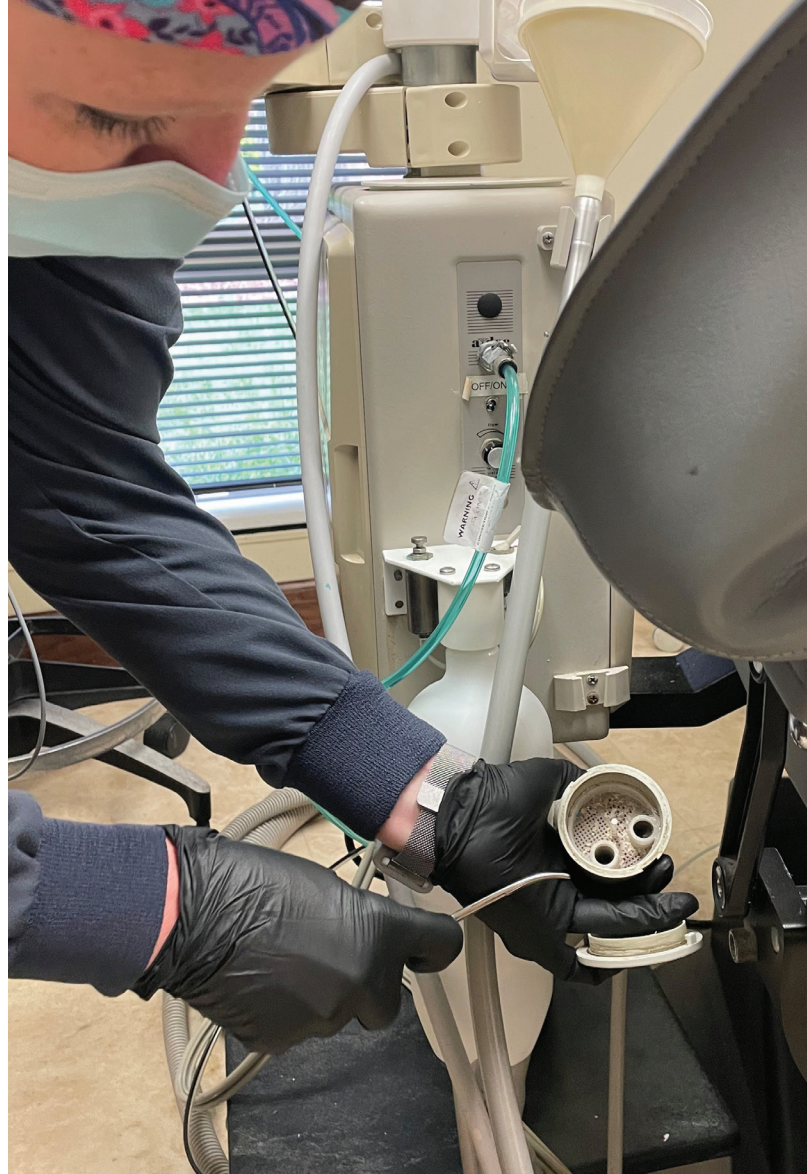
A four-operator practice noted a palpable drop in chairside suction power during aerosol-generating procedures. Initial baseline testing using a specialized flowmeter device revealed an isolated reading of 7.6 SCFM. However, dental practices do not operate in a vacuum of

a single operator. When a second, adjacent operator was activated, the airflow in the primary room plummeted below 5.0 SCFM—falling dangerously short of safe aerosol mitigation standards.

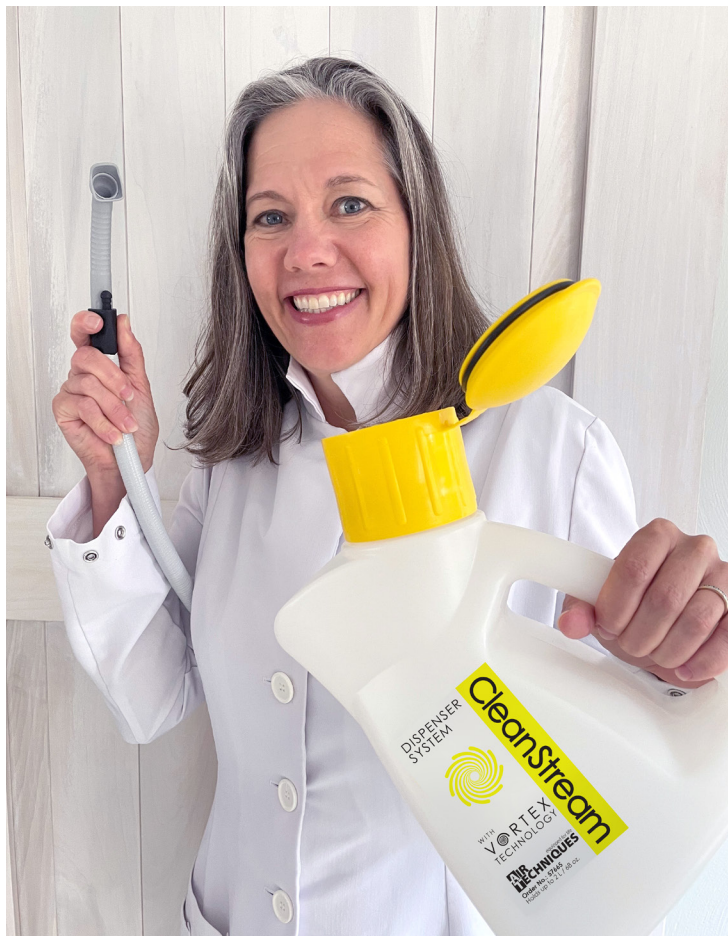
Baseline Flow: 7.6 SCFM

Phase 1: Daily Atomized Cleaning (CleanStream)

3-Month Flow: 8.7 SCFM

Phase 2: Tubing Replacement (\$300 Investment)

Final Flow: 9.1 SCFM

Phase	System Status	Measured Airflow (SCFM)	Performance Increase
Baseline	Clogged traps, weekly bucket flushing	7.6 SCFM	Reference Point
Phase 1	3 Months of daily CleanStream atomization	8.7 SCFM	+14.5%
Phase 2	Chemical line cleaning + New physical tubing	9.1 SCFM	+19.7% total

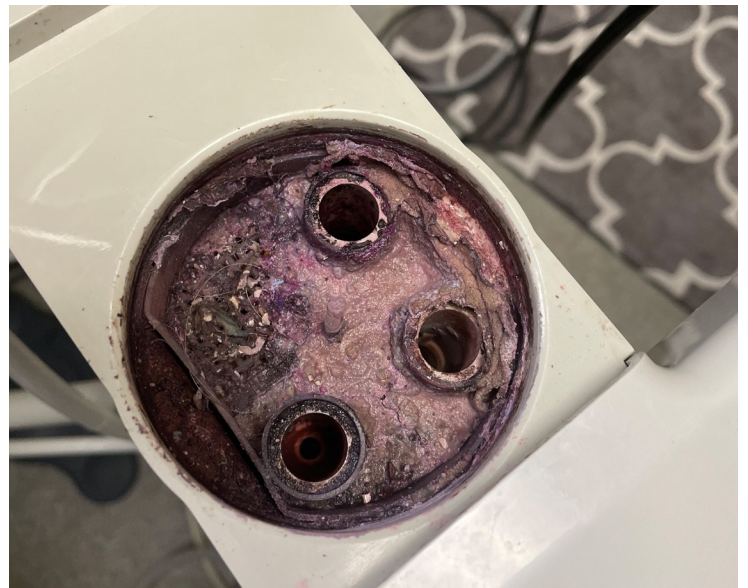
- Chairside Solids Traps: Scheduled for replacement every Monday.

2. Rigorous Trap Maintenance Protocol

A strict calendar-based schedule was introduced to manage the initial surge of dislodged, legacy bio-burden:

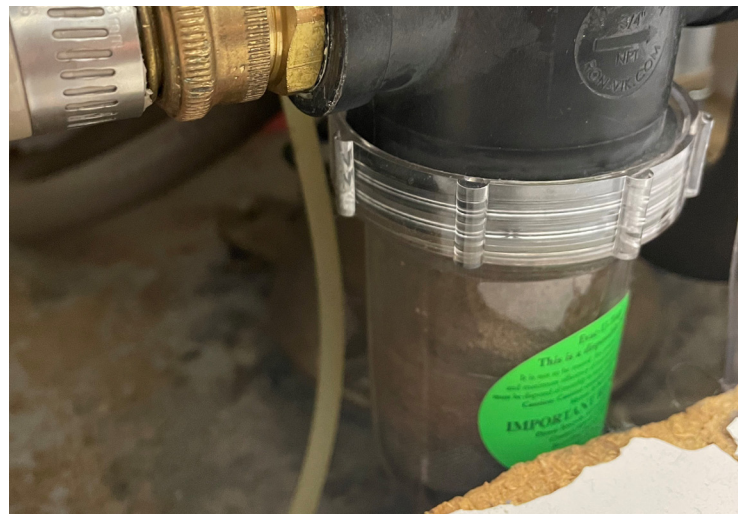
- Central Vacuum Main Trap: Scheduled for replacement on the 15th of every month.

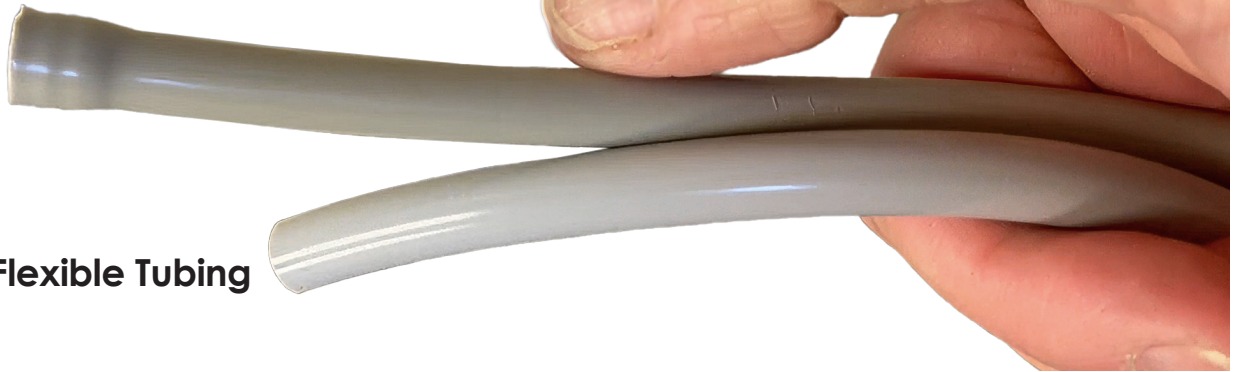
Old Stiff Tubing

Old, discolored internal suction tubing was identified as a source of permanent luminal narrowing due to years of

calcified buildup. The practice replaced all HVE and saliva ejector tubing across all four operatories with lightweight, ergonomic alternatives.

New Flexible Tubing
